Roads and Pavements № 290

Stephenson Drive

📍 Leicester, UK

CONSTRUCTED IN 2011

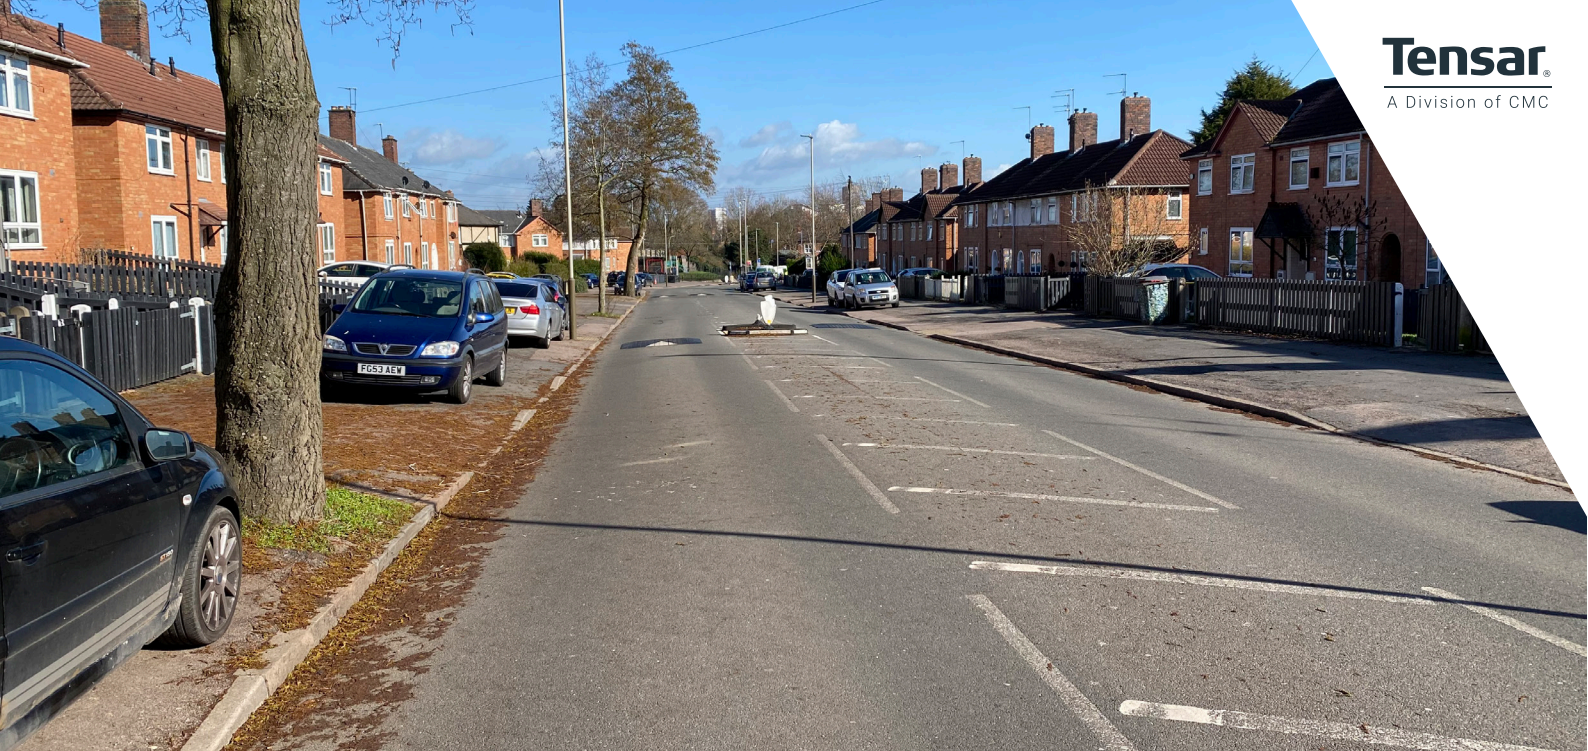
Photo of Stephenson's Drive taken in 2021 which demonstrates more than 10 years post installation in-service life.

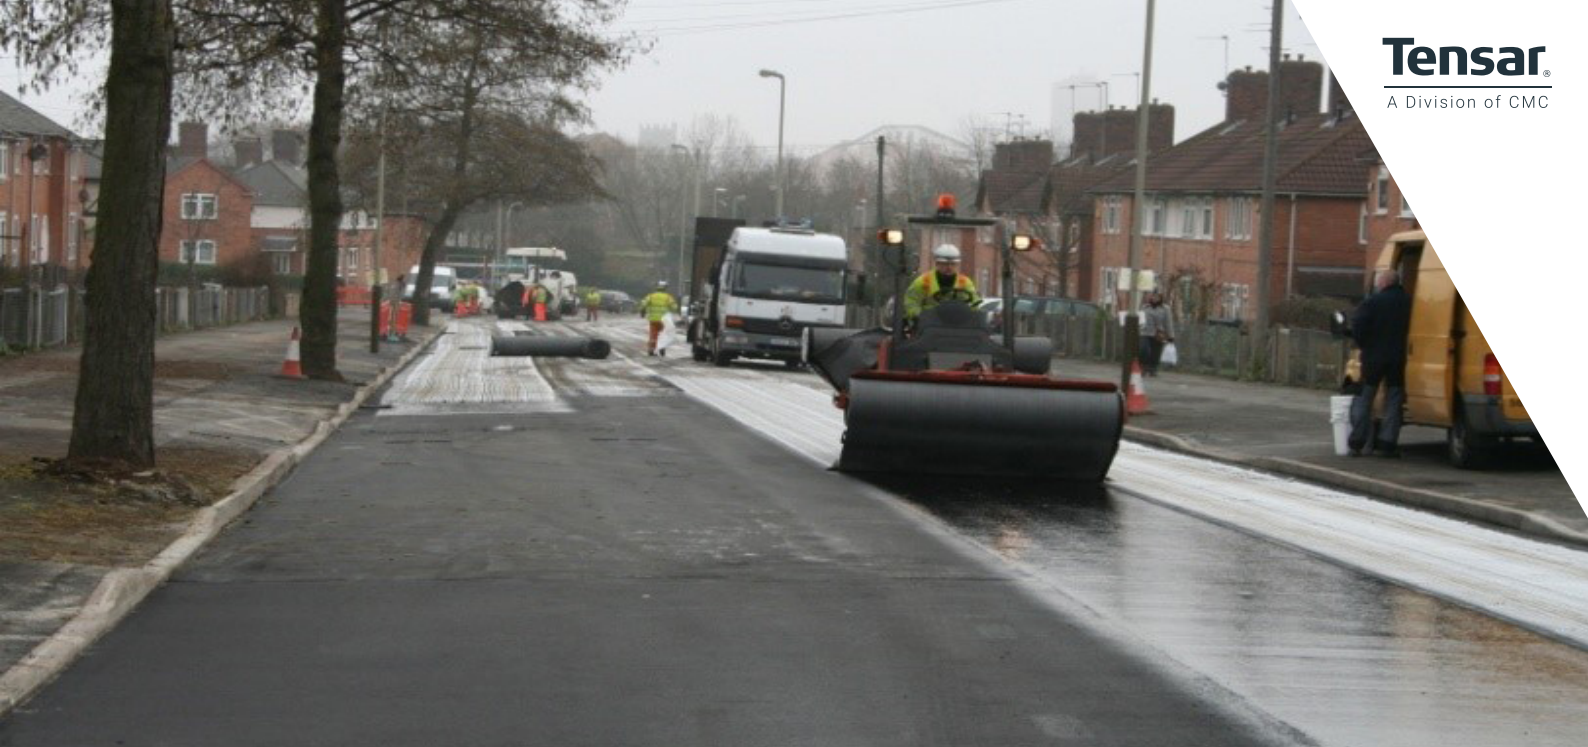
Tensor Glasstex was used by Leicester City Council to mitigate potential for reflective cracking on Stephenson Drive

To mitigate the effects of the reflective cracking in the new asphalt surface layers, Tensor proposed Glasstex composite asphalt interlayer as a stress absorbing membrane interlayer (SAMI) to help dissipate the stress from potential movement in the unstable concrete foundation and as such, potentially halve the road maintenance requirements.

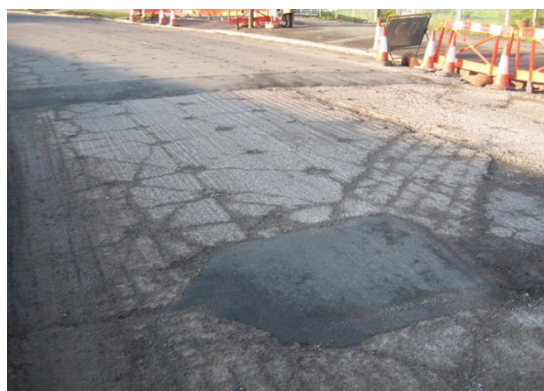
Crack and seat before regulating course

Leicester City Council Highways & Drainage Department had improved the stability of the concrete through a specialist crack and seat process, but some differential movement potentially remained, which would be exacerbated by tree root growth and inevitable service trench excavation and filling. It was estimated this would have needed wide scale maintenance within a maximum of 10 years had provision not been made for a SAMI.

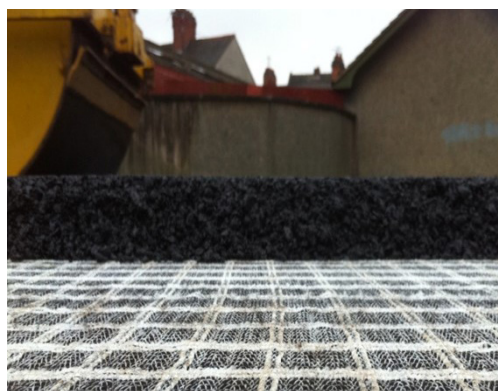
Tensor Glasstex P100 is laid to mitigate against reflective cracking and limit its spread into the newly laid asphalt course

To achieve an asphalt surface which would accommodate this residual instability, Bardon Contracting started by installing a 0/6mm sand asphalt regulating course to provide a smooth layer over the uneven broken concrete foundation. Foster Contracting then sprayed a bond coat of 160/220 pen straight run bitumen @ 1.1 l/m² using one of their own calibrated tankers, immediately followed by their specially developed plant to install the Glasstex P100 composite directly onto the bitumen bond coat layer.

Due to instant break time of the 160/220 pen bitumen bond coat, the installation of the final 40mm asphalt surface course could commence immediately, causing no delay to the surfacing operations.
