Deep rut no more with Tensar® InterAx®

Arcadia Retirement Village, Yeronga

70 Park Rd, Yeronga, Australia

Working Platforms | No. 537

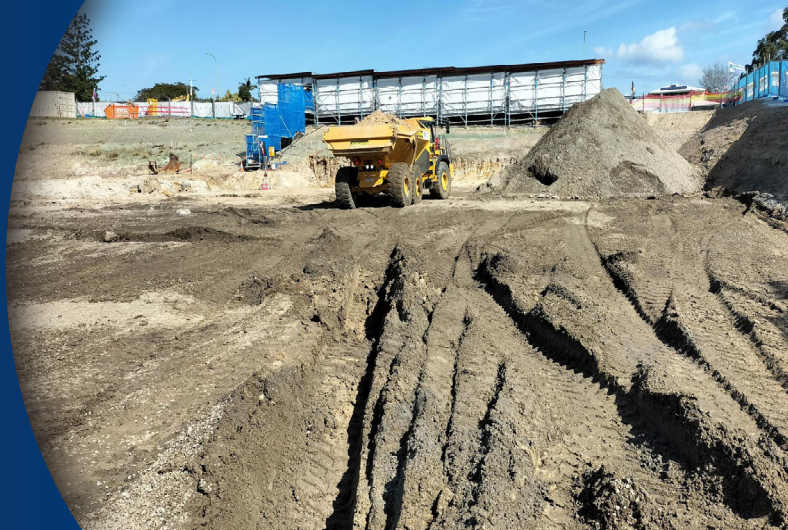
Over a soft clay subgrade, a laden dump truck failed a proof roll, causing severe rutting up to 500mm on the platform of a new retirement village being constructed. The contractor was resigned to remove and replacing the earthworks, but the geotechnical consultant sought alternatives.

The geotechnical consultant recommended a mechanically stabilised layer (MSL) using 2 layers of Tensar InterAx geogrid – 1 at the base and 1 mid-way. Contractor only had to dig out 500mm worth of material to reconstruct the platform, saving 300mm fill material and several days of construction.

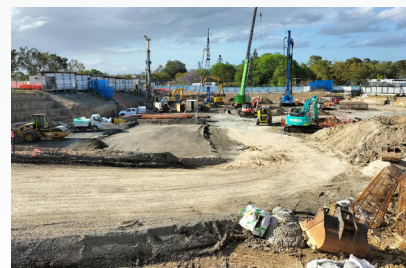
No deep rutting was observed on the stabilised platform.
