## Solving the problem of cracks on fen roads

### Common Lane, Broomfleet.

East Riding, UK

To solve the problem of severe movement on fen roads in Broomfleet, Tensar's Glasstex asphalt interlayer product was installed. This process was completed during resurfacing to reinforce the bituminous layer and prevent water from penetrating into the sub-base. The Glasstex will also control cracking on the surface course.

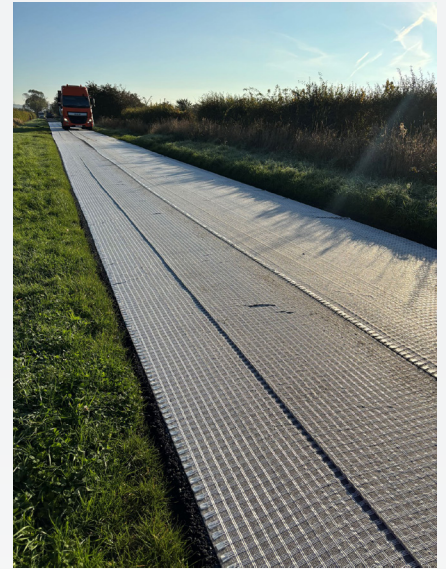
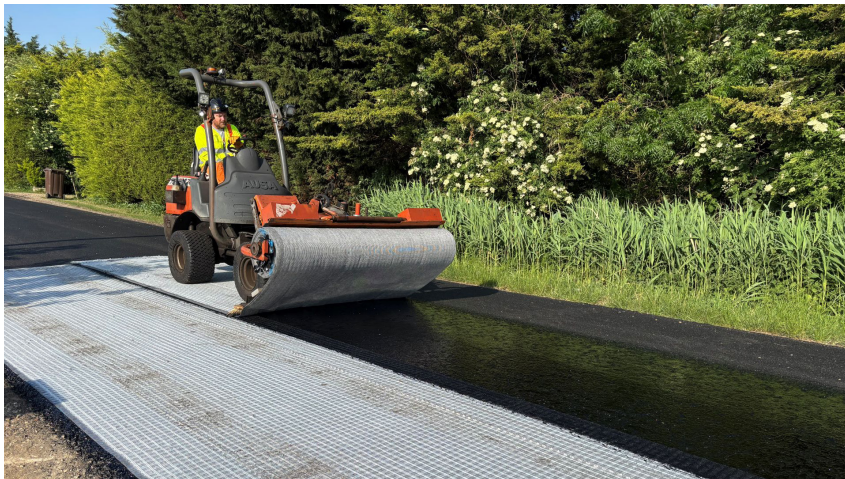
The Tensar solution was a Glasstex reinforcement material saturated with bitumen to create an impermeable layer that stops water ingress if any cracks were to appear on the surface course. Once installed, the Glasstex solution provided both reinforcement and stress relief between the different layers of asphalt materials and the barrier to stop the water penetrating further down into the sub-base.

Fen roads fail twice as fast as those on stable ground requiring maintenance up to four times as often during the lifecycle of the road. Interlayers act as a water barrier stopping the foundation and sub-grade from weakening. In addition, they will help to absorb horizontal and vertical movements preventing cracks from tearing through the new surface course.
